DISC-E-95GP-0301

REPORT OF FINDINGS: ENGINEERING PRACTICES STUDY ON FAILURE ANALYSIS OF
NSN 5340-00-136-9872 GROOVED COUPLING CLAMP

Bohdan Hasiuk
Defense Industrial Supply Center
DISC-ECM
700 Robbins Avenue
Philadelphia, PA 19111-5096

3 October 1988

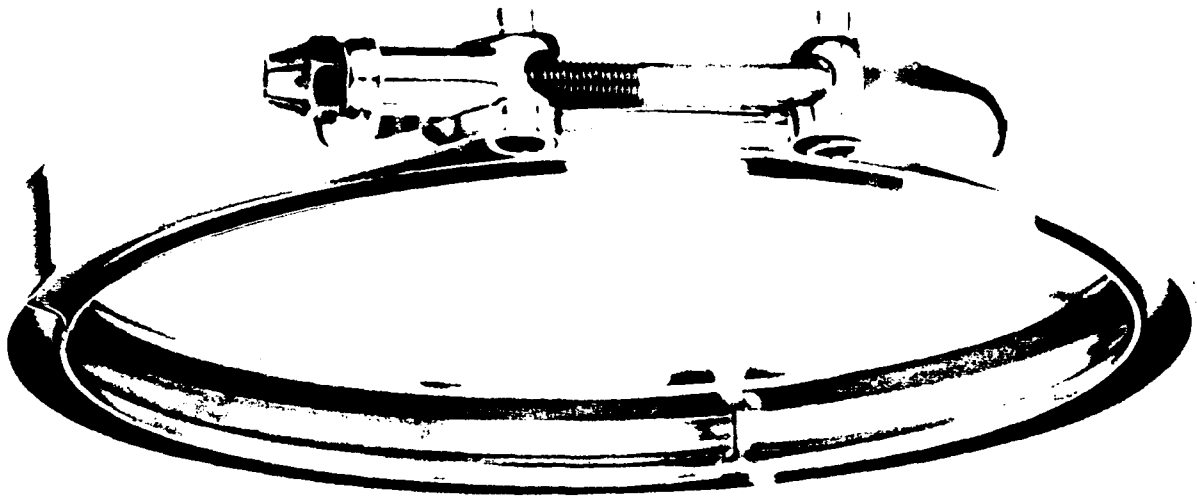
Figure 2. An isometric of the NSN 5340-00-136-9872 V-Band Coupling Clamp made by National Utilities Corporation to Dwg: 4606AC.

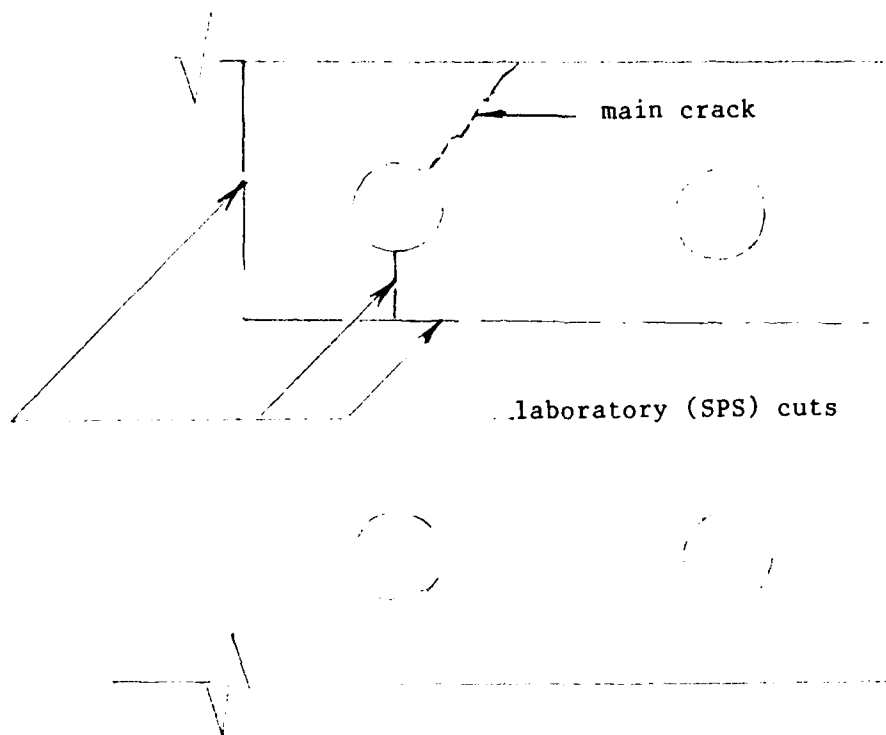
Figure 3-3.25X. A sketch of the inside surface of the clamp segment from figures 2B and 2C containing the crack. A part of this clamp segment was cut out and the crack was opened and is shown in figures 3A and 3B.

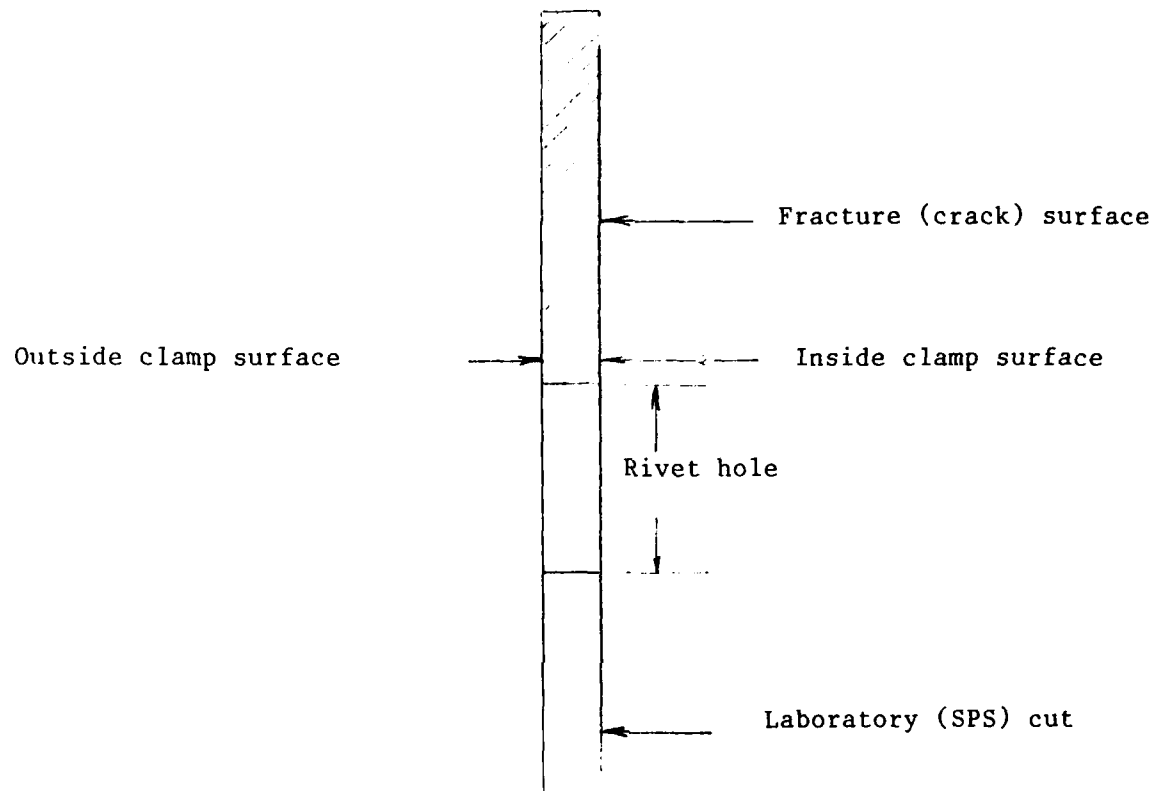
Figure 3A-9.75X - A sketch, from figure 3, of the opened main crack and its relation to the clamp segment. A more detailed sketch of the crack surface is shown in figure 3B.

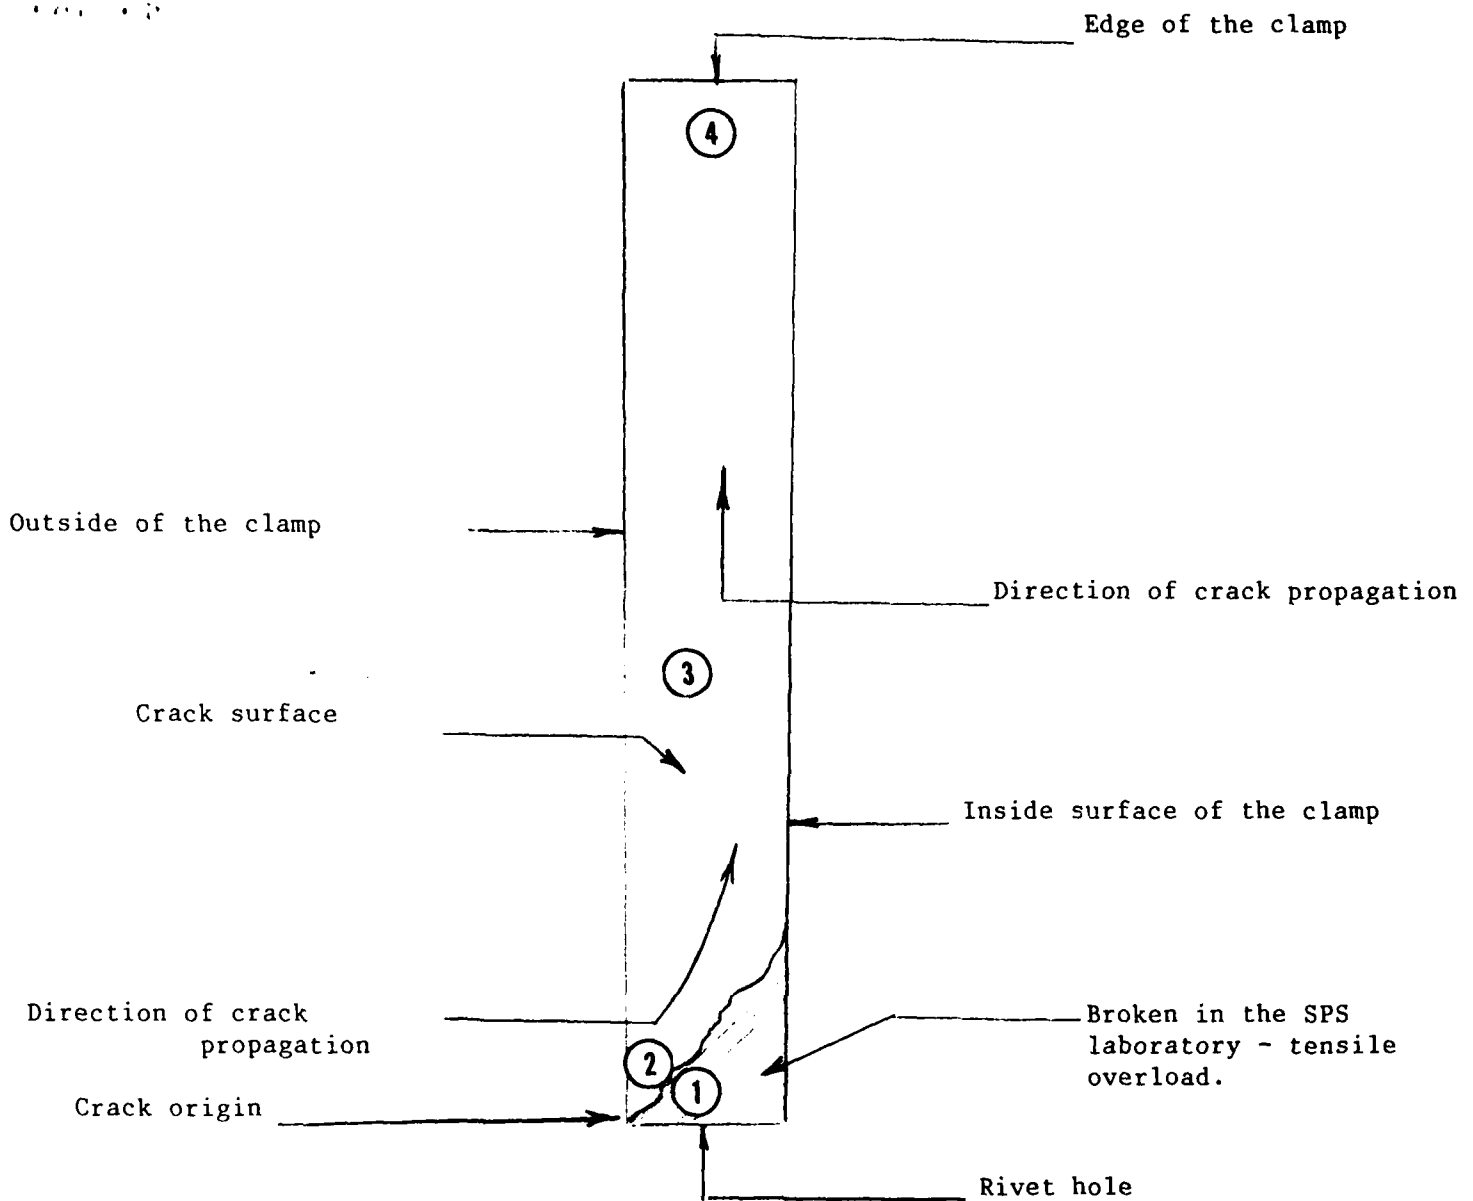
Figure 3B-20X. A sketch of the crack surface from figure 3A. The surface of this crack was examined by the Scanning Electron microscope (SEM) and was analyzed by Energy Dispersive Spectroscopy (EDS) and the representative areas (labeled 1 through 4 in this sketch) were photographed and the results are shown in figures 4 through 5A.

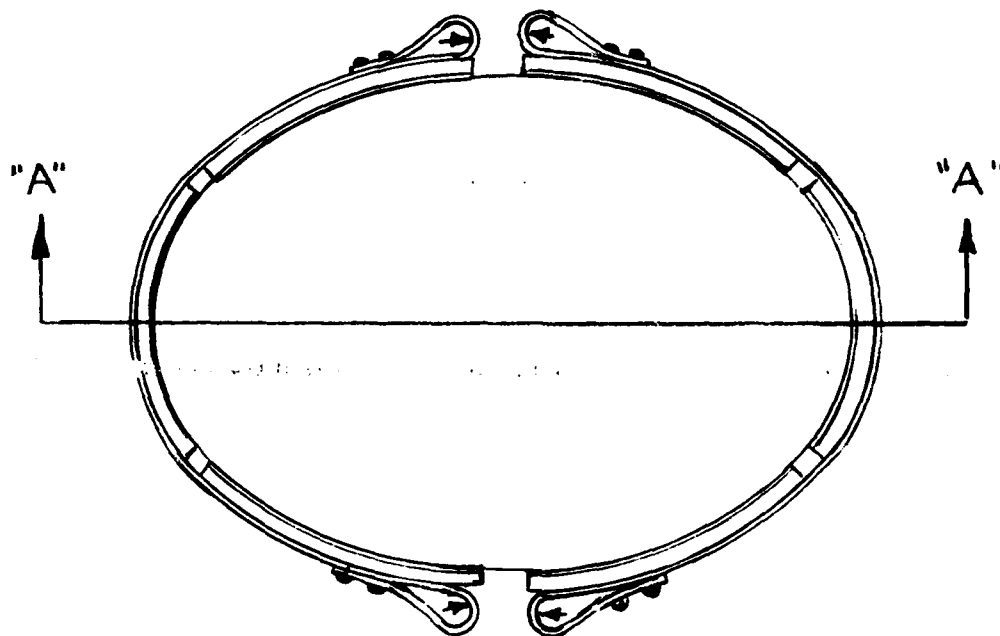
Taking the geometry of the cross-section of the entire clamp under consideration, the metal temperature of the exhaust pipe of the OH-58 helicopter would have to be considerably above 1000 F to cause the temperature of the outside clamp surface to reach 1000 F. This is graphically portrayed in figure 8.

Figure 8-0.55X. A sketch of the coupling clamp (which holds the exhaust pipe of the OH-58 helicopter). Section "A-A" is shown in figure 8A.

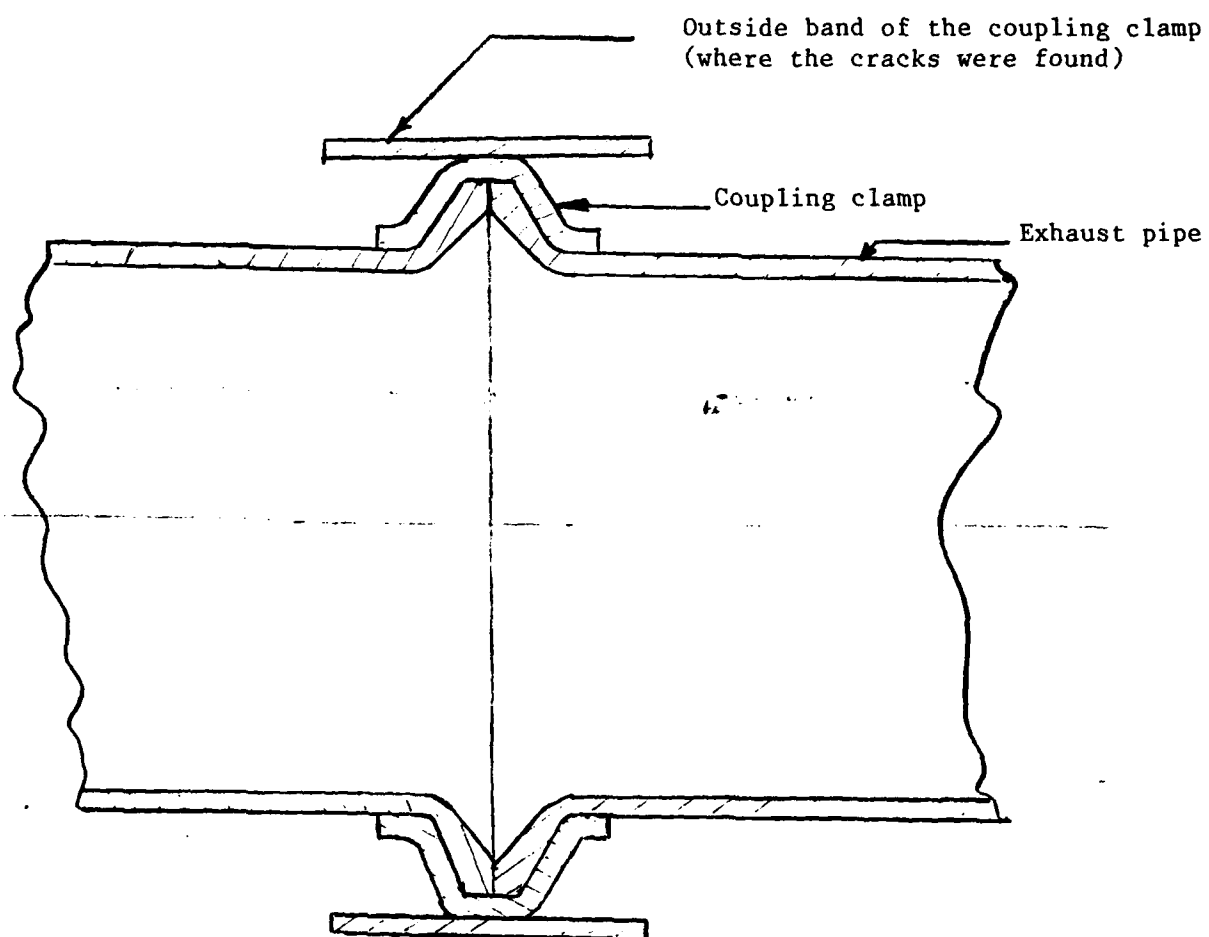
Figure 8A - 0.44X. Section "A-A" from figure 8 showing the cross-section of the coupling clamp and the exhaust pipe of the OH-58 aircraft.

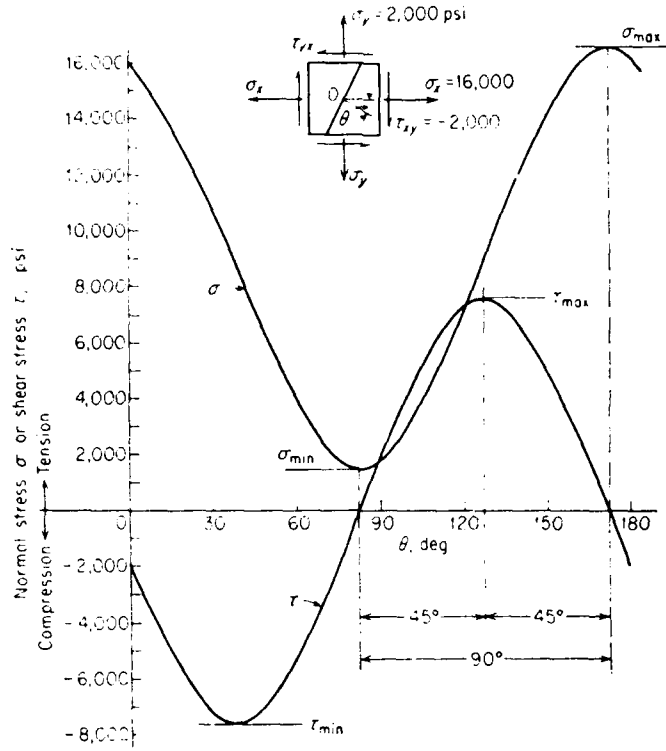
As the tail pipe heated up, the clamp band began to experience thermal tensile stresses, (superimposed on the normal mechanical tensile/bending stresses) as was stated heretofore: the outside surface of the clamp was in (thermal) tension and the inside surface in (thermal) compression. Because of the clamp band geometry a two dimensional (plane stress) state of stress can be applied to this situation (8). The normal stresses in this state of stress are maximum in the longitudinal (circumferential) direction and minimum (in this situation close to zero) in the transverse (90 degrees to the longitudinal) direction. In such a state of stress the maximum shear stress will be at 45 degrees to the maximum normal stress. This is graphically portrayed in figure 9.

Figure 9. Variation of normal (tensile) stress σ with shear stress τ . The shear stress is at a maximum 45° away from the maximum normal (tensile) stress. (Dieter, George E. Jr. mechanical metallurgy, p. 21)
